A REVIEW OF THE JORDAN SISTERS COLLECTION HISTORIC ST. LUKE'S CHURCH ISLE OF WIGHT COUNTY, VIRGINIA

Alain C. Outlaw

September 30, 2008

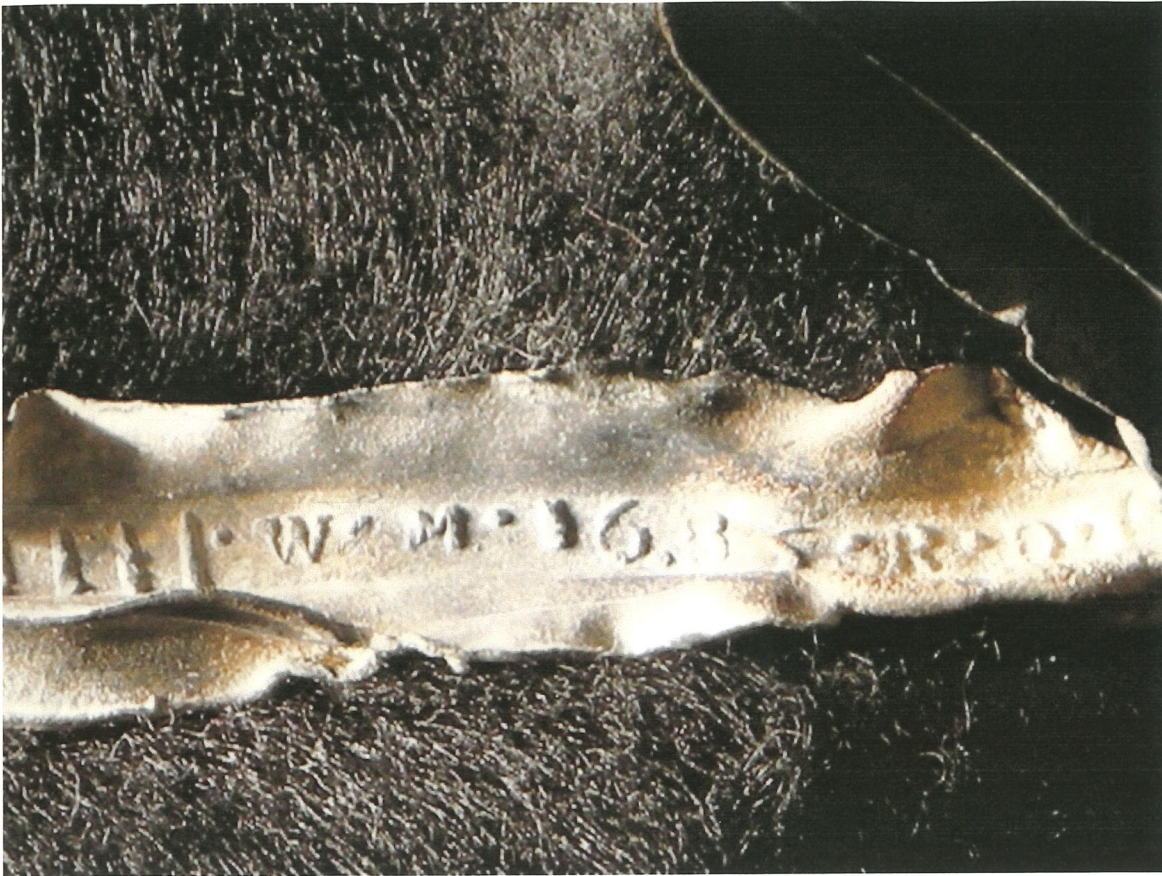
Figure 2. Detail of inscription in base of turned lead channel (·W·M·1685·R·D·).

following embossed inscription was found in the channel of two of the joined pieces:
·W·M·1685·R·D· (see Figure 2).

Although the names matching these master and journeyman or vice-maker and glazier initials (WM and RD) are unknown, this evidence indicates that these St. Luke's casement windows were made no earlier than 1685 (Egan *et al.* 1986:307). Interestingly, one of the English Glazier's charters was dated 1685, showing a continuing concern for "quality control" in the craft, perhaps expressed by the identification of who was specifically responsible for their production by way of marks, as in other crafts. The leads are probably the same age as the small, undated fragment discovered by ACS in the drainage trench in 2007. Fortuitously, the dated fragment is nearly the same length as the side of a complete window pane recently discovered at the Nicholas Spencer archaeological house site at Hotwater, in James City County, where the Governor's Council met in 1683 (see Figure 3). This diamond-shaped glass window pane is 6" high and 4-1/10" wide, and provides a possible restoration parallel for St. Luke's.

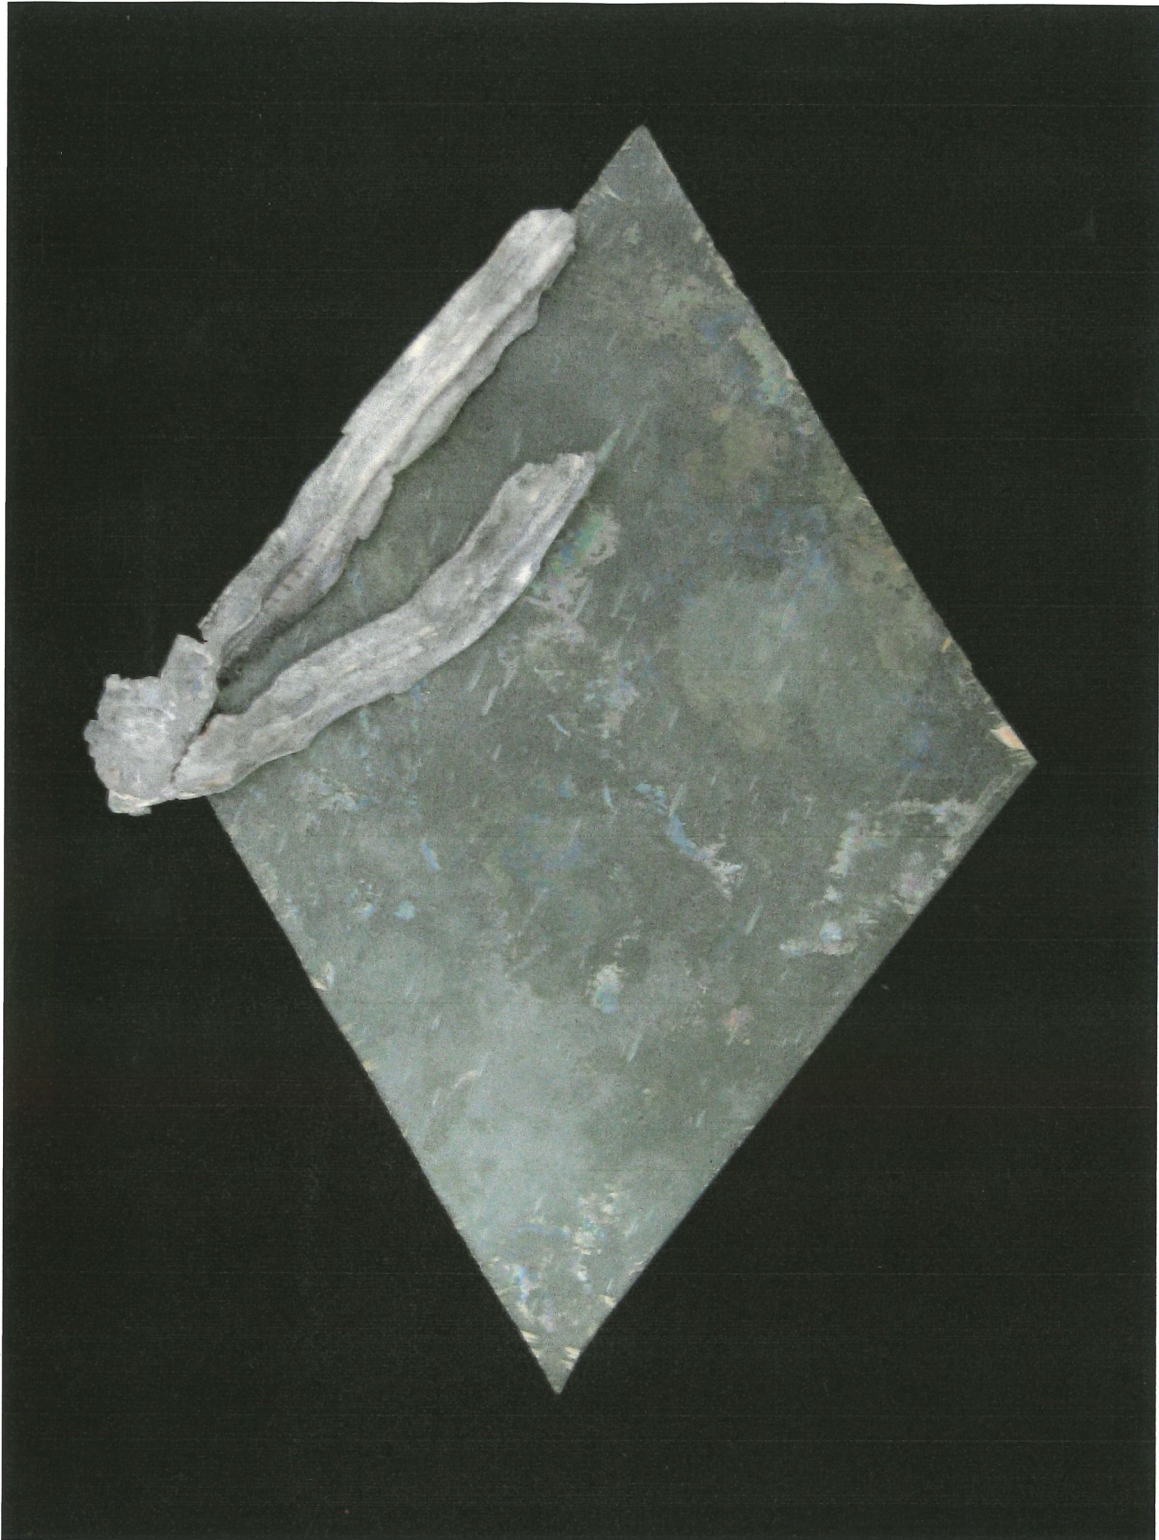
Figure 3. Dated window came from St. Luke's Church superimposed on complete window pane from the Nicholas Spencer archaeological site, James City County, Virginia.

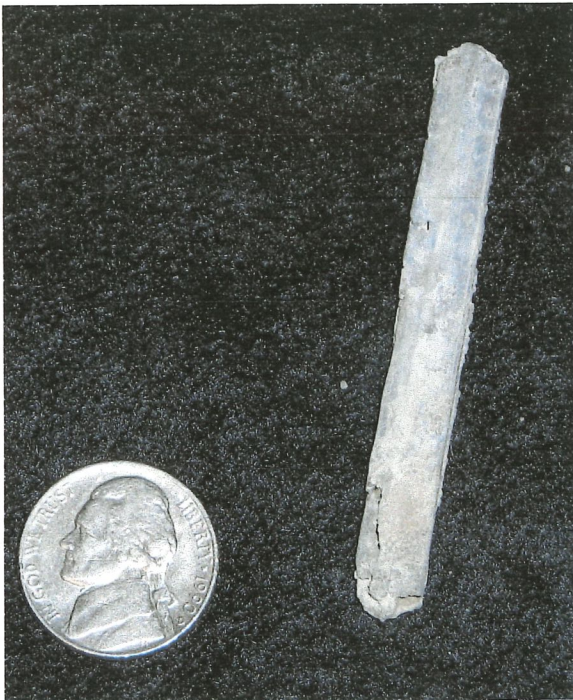
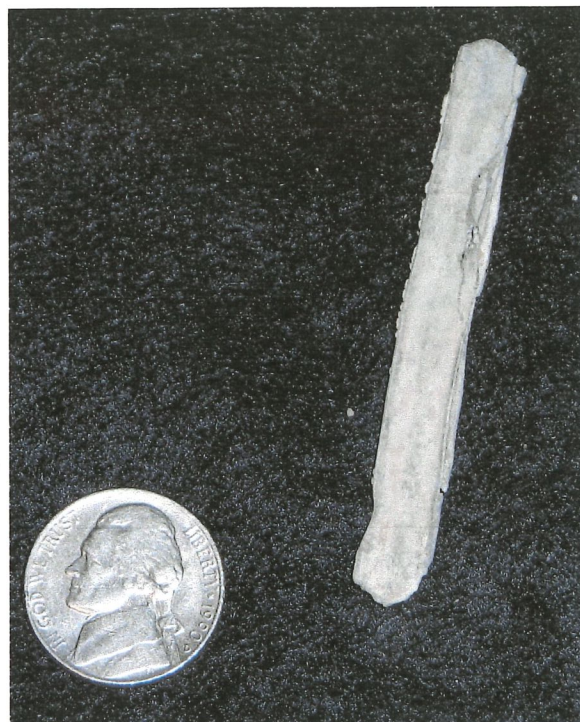
Fragment 1: Front View and Reverse View

Condition Description: The lead was fragile and corroded. Dirt was observed in the center of the folded came.

- 08/14/08 Window came was examined at St. Luke's Church. It was noted that some of the came fragments were beginning to crumble along the edges.
- 08/16/08 Lightly brushed with a soft, natural bristle brush to remove loosened dirt and corrosion. Rinsed in distilled H₂O.

- 08/23/08 The folded leads were heated to soften the brittle lead and then unfolded so that the corrosion along the center channel could be removed. The lead was lightly brushed to remove loosened soils with a soft, natural bristle brush. It was then rinsed in distilled H₂O. Artifacts were placed in a small tray, covered with a white paper towel and allowed to completely air dry. It was noted that the largest segment of came contained initials and a date on the interior channels which read, "W·M·1685·R·D"
